**Flood Control Project Maintenance
Levee Inspections**

Fall 2018 Levee Maintenance Deficiency Summary Report

Sacramento River Basin

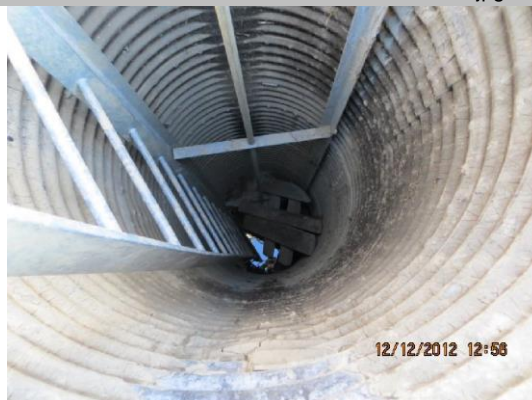
Photo 2 of 2 : UCIP_FA_2018_51689_47180.jpg

Waterside view: inside CMP riser

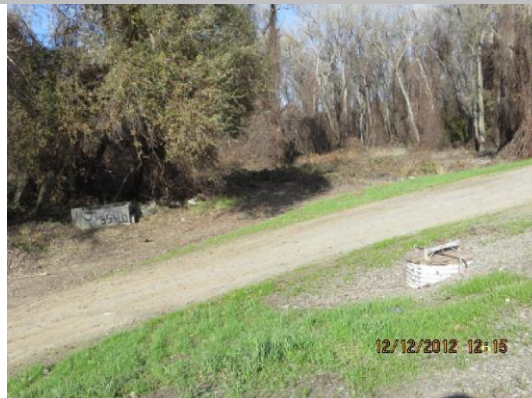
Photo 1 of 3 : UCIP_FA_2018_51694_47189.jpg

Comment Code					
Inspector Comment					
FS_ID:51694 DS_ID:17300 EP_NO: N/A Repair Type: Non-Urgent Crossing Status: Indicator Found UCIP Comments: 4/19/2017 Abandoned- needs to be done properly. (DWR Sutter Yard- AFreitag)10/31/2016 Abandoned (DWR Sutter Yard- Afreitag)6/1/2016 Abandoned4/1/2015 Only cmp riser and slide gate found on WS.Abandoned riser with slide gate on WS. Abandoned concrete surge box on WS. Verify pipe has been abandoned properly. 6/30/2014 Same as last inspection.12/18/2013 Same as last inspection.7/23/2013 Same as last inspection. FIELD_STRUCT_DESC: *ABANDONED* 24-inch corrugated metal drainage pipe through the levee, 14.5 feet below the crown, not found in 2015. Slide gate in a concrete surge box on the waterside (WS) berm, found in 2015. Slide gate in a corrugated metal pipe (CMP) riser, found in 2015. Pump on the WS slope, not found in 2015. [Additional Reference(s): DWR Levee Log, 2002. USACE Sacramento O&M Manual 136, March 1960 (HLM 7.61)]. FS Date: 4/26/2017 2:37:43 PM

Waterside view: overview

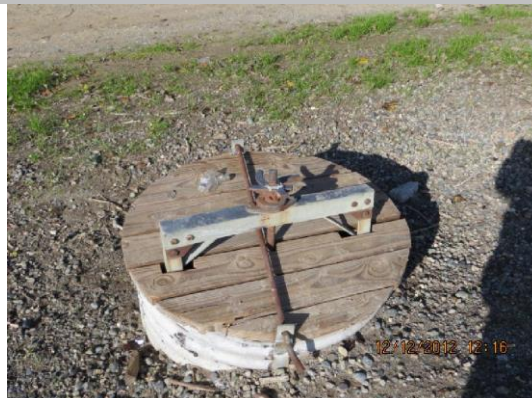
Photo 2 of 3 : UCIP_FA_2018_51694_47188.jpg

Waterside view: CMP riser with slide gate

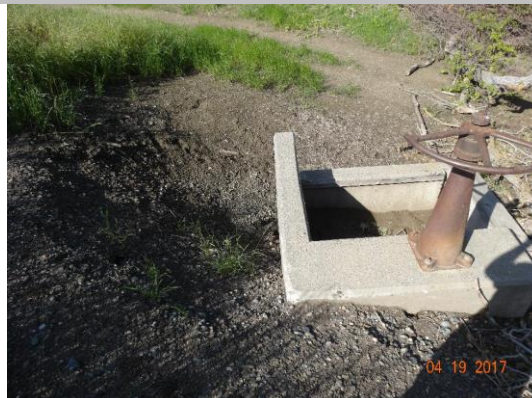
Photo 1 of 3 : UCIP_FA_2018_51695_77008.jpg

FS_ID:51695
DS_ID:17301
EP_NO: 9532
Repair Type: Non-Urgent
Crossing Status: Found
UCIP Comments: 4/19/2017 Abandoned- erosion/depression present around the WS box (DWR Sutter Yard- AFreitag)10/31/2016 Abandoned and erosion still present near WS box.(DWR Sutter Yard- AFreitag)6/1/2016 Appears to be an abandoned crossing.4/1/2015 Silted concrete box on WS. Depression/erosion around concrete box on WS.Silted concrete box on WS. Depression/erosion around concrete box on WS.6/30/2014 Same as last inspection.12/18/2013 Same as last inspection.7/23/2013 Same as last inspection.
FIELD_STRUCT_DESC: *ABANDONED* 36-inch by 48-inch reinforced concrete box drainage culvert through the levee, 11.6 feet below the crown. Slide gate in a concrete box on the waterside (WS) slope. (3-foot by 4-foot culvert [HLM 7.73] authorized under Automatic Board Order (ABO) issued as Permit No. 9532, 1974 - Martin). [Additional Reference(s): DWR Levee Log, 2002. USACE Sacramento O&M Manual 136, March 1960 (HLM 7.73)].

Depression around WS concrete box

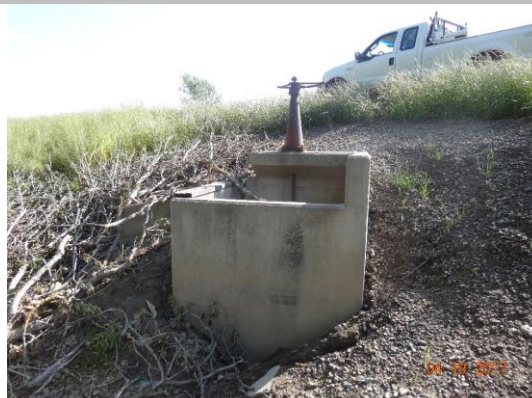
Photo 2 of 3 : UCIP_FA_2018_51695_77009.jpg

depression around WS concrete box

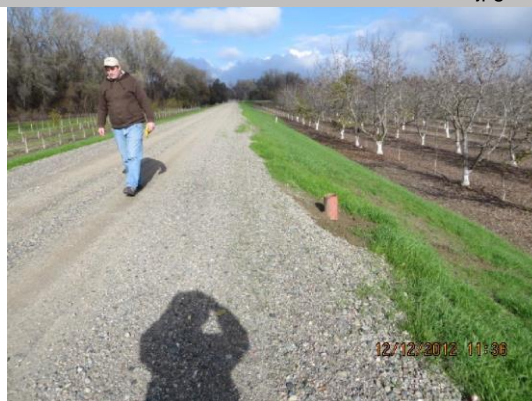
Photo 1 of 3 : UCIP_FA_2018_51724_47206.jpg

Comment Code						
Inspector Comment						
FS_ID:51724 DS_ID:17338 EP_NO: N/A Repair Type: Non-Urgent Crossing Status: Indicator Found UCIP Comments: 4/19/2017 Still only LS airvent found. (DWR Sutter Yard- Afreitag)10/31/2016 Only the LS standpipe and airvent found.6/1/2016 Still only the vaccum breaker on LS shoulder visible.4/1/2015 Only vacuum breaker found on LS shoulder.6/30/2014 Same as last inspection.12/18/2013 Same as last inspection.7/23/2013 Same as last inspection. FIELD_STRUCT_DESC: Pipe of unknown diameter, purpose and material through the levee, at an unknown depth below the crown, not found. Vacuum breaker inside steel standpipe on the landside (LS) shoulder, found in 2015. [Additional Reference(s): DWR Levee Log, 2002]. FS Date: 5/1/2017 8:31:33 AM

Waterside view: overview

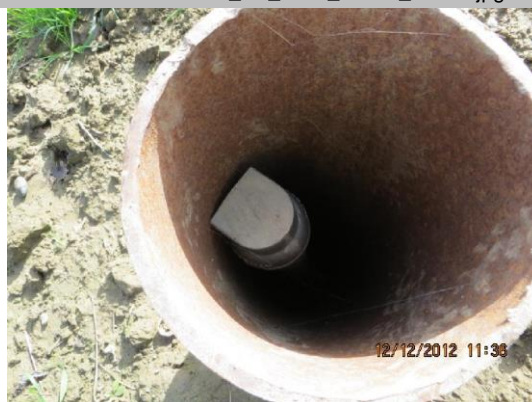
Photo 2 of 3 : UCIP_FA_2018_51724_47205.jpg

Waterside view: vacuum breaker inside a steel pipe

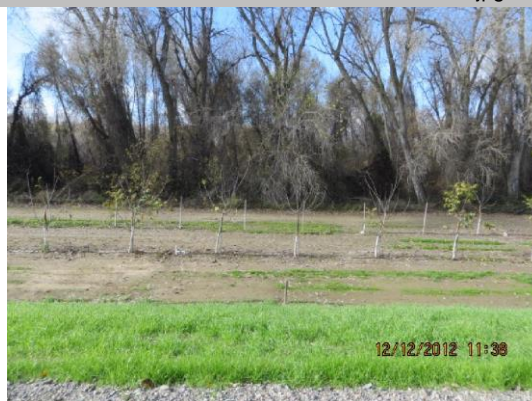
Photo 3 of 3 : UCIP_FA_2018_51724_47204.jpg

Landside view: overview (no pipes)

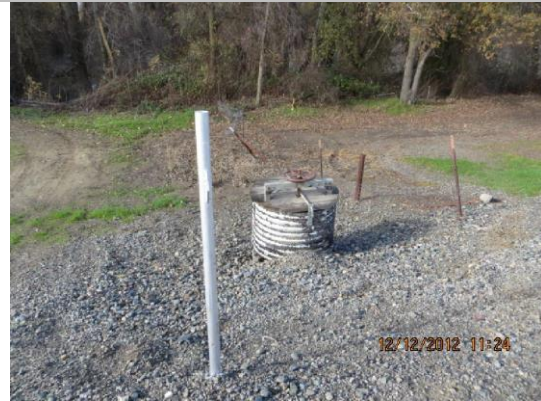
Photo 1 of 3 : UCIP_FA_2018_51725_47208.jpg

FIELD_STRUCT_DESC: *ABANDONED* 24-inch irrigation and drainage pipe through the levee, invert 11.5 feet below the crown. Slide gate in a corrugated metal pipe (CMP) riser on the waterside (WS) slope. (24-inch pipe [HLM 8.55] authorized under Automatic Board Order (ABO) issued as Permit No. 9529, 1974 - Dorwood Ranching Co.) [Additional Reference(s): DWR Levee Log, 2002. USACE Sacramento O&M Manual 136, March 1960 (HLM 8.55)]
FS Date: 5/1/2017 8:37:22 AM

Waterside view: overview of CMP riser

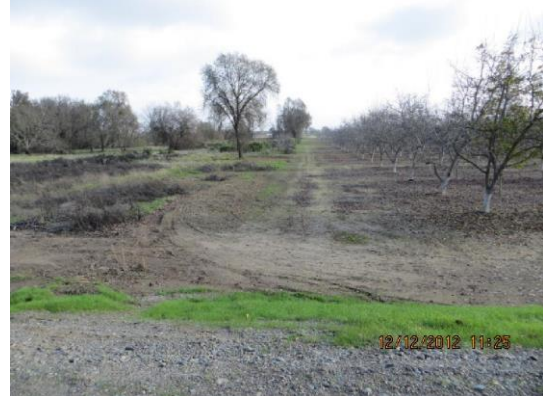
Photo 2 of 3 : UCIP_FA_2018_51725_47207.jpg

Landside view: overview (no pipes)

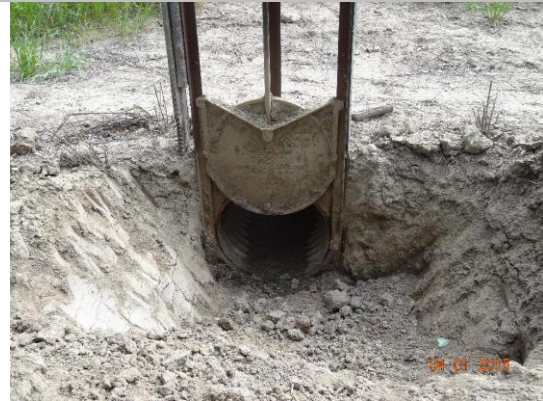
Photo 3 of 3 : UCIP_FA_2018_51726_73649.jpg

WS pipe end

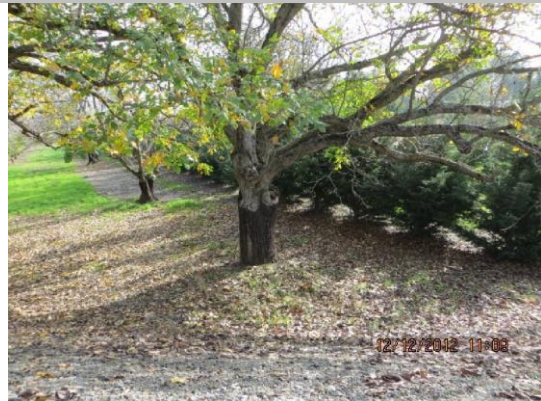
Photo 1 of 3 : UCIP_FA_2018_51728_74662.jpg

Comment Code					
Inspector Comment					
FS_ID:51728 DS_ID:17352 EP_NO: 9523 Repair Type: Non-Urgent Crossing Status: Indicator Found UCIP Comments: 4/19/2017 Abandoned- needs to be done so properly. (DWR Sutter Yard- Afreitag)10/31/2016 Abandoned. (DWR Sutter Yard- Afreitag)6/13/2016 Abandoned crossing.4/14/2016 Appears abandoned and if so, should be done so properly. Borrowing activity on landside (LS).8/28/2015 Pipe has been dug up and located along the WS levee toe.6/30/2014 Unable to locate.12/18/2013 Unable to locate.7/23/2013 Same as last inspection. Unable to locate. FIELD_STRUCT_DESC: *ABANDONED* 10-inch concrete encased steel drainage pipe through the levee, invert 15 feet below the crown, not found in 2016. Gate valve in a 42-inch corrugated metal pipe riser on the waterside (WS) slope, found in 2016. (10-inch pipe [HLM 8.7] authorized under Automatic Board Order (ABO) issued as Permit No. 9523, 1974 - Blackmore). Additional Reference(s): DWR Levee Log, 2002. USACE Sacramento O&M Manual 136, March 1960 (HLM 8.7)]. FS Date: 5/1/2017 8:59:37 AM

View of LS

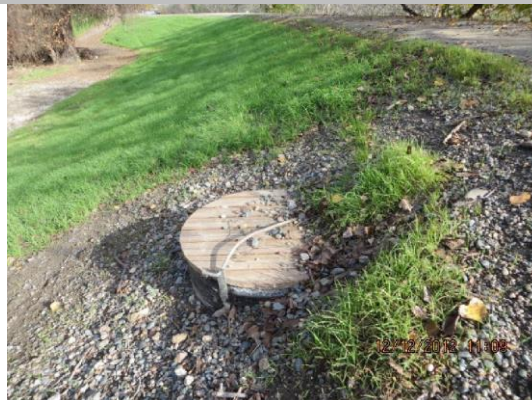
Photo 2 of 3 : UCIP_FA_2018_51728_74661.jpg

42-inch riser on WS shoulder.

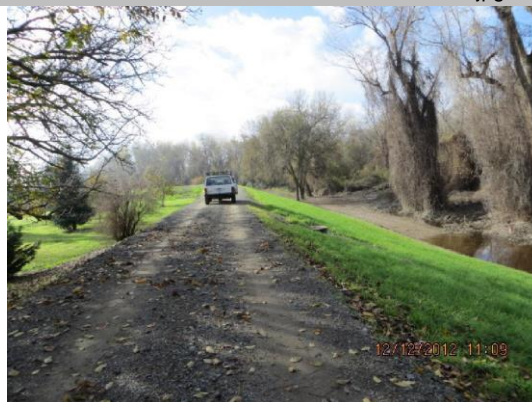
Photo 3 of 3 : UCIP_FA_2018_51728_74660.jpg

View from crown of levee looking downstream.

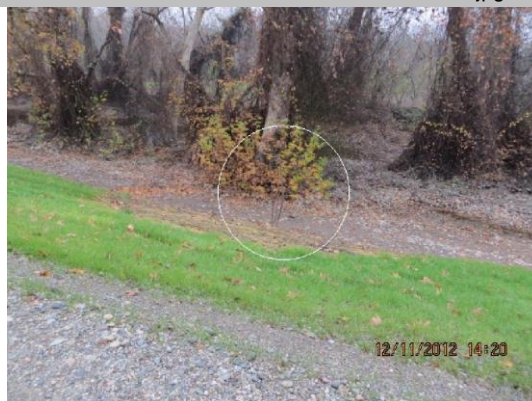
Photo 1 of 3 : UCIP_FA_2018_53402_47216.jpg

Comment Code					
Inspector Comment					
FS_ID:53402 DS_ID:17353 EP_NO: 4491 Repair Type: Urgent Crossing Status: Found UCIP Comments: 8/30/2018 Same as last inspection; could not find LS pipe end so recommend internal pipe inspection. Crossing to remain Urgent (D. Sanoski - DWR UCIP).4/19/2017 4in. pipe still showing signs of deterioration near WS toe. (DWR Sutter Yard- Afreitag)10/31/2016 Pipe still exposed along the WS toe and is rusted and corroded. If it is still in use by the owner then it should be rebuilt.(DWR Sutter Yard- Afreitag)6/13/2016 Pipe was dug up on WS and photographed. It was originally selected for internal inspection but was unable to be as there was no access to the inside of the 4" pipe. (DWR Sutter Yard - afreitag)4/14/2016 Signs of corrosion on pipe and valve on LS. Pipe in use according to Bryan Reniff of Sutter Yard. (DWR UCIP - kfazel)8/28/2015 Pipe was dug up and located on the WS levee toe. (DWR Sutter Yard - afreitag)6/30/2014 Same as last inspection. (DWR Sutter Yard - afreitag)12/18/2013 Same as last inspection. (DWR Sutter Yard - afreitag)7/23/2013 Same as last inspection. (DWR Sutter Yard - afreitag)12/11/2012 Only abandoned slide gate found on WS. (DWR UCIP - pamatya) FIELD_STRUCT_DESC: 4-inch steel drainage pipe sleeved through 24-inch corrugated metal pipe through the levee, 16.7 feet below the crown. Annular space has been pressure grouted. Slide gate on the waterside (WS) end. Gate valve at the landside (LS) toe. (Permit No. 4491, 1964 - Blackmore). [Additional Reference(s): DWR Levee Log, 2002. USACE Sacramento O&M Manual 136, March 1960 (HLM 8.74)]. FS Date: 8/30/2018 4:27:57 PM

Waterside view: overview of slide gate on steel structure (belongs to crossing at CLM-8.782)

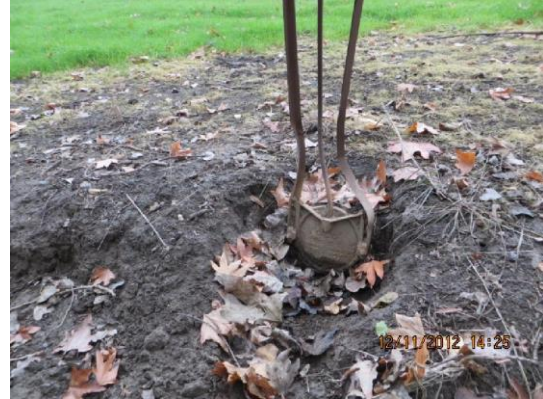
Photo 2 of 3 : UCIP_FA_2018_53402_47215.jpg

Waterside view: slide gate on steel structure (belongs to crossing at CLM-8.782)

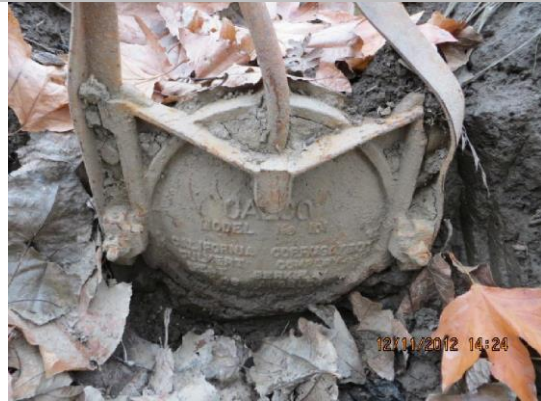
Photo 3 of 3 : UCIP_FA_2018_53402_47214.jpg

Waterside view: close view of slide gate (belongs to crossing at CLM-8.782)

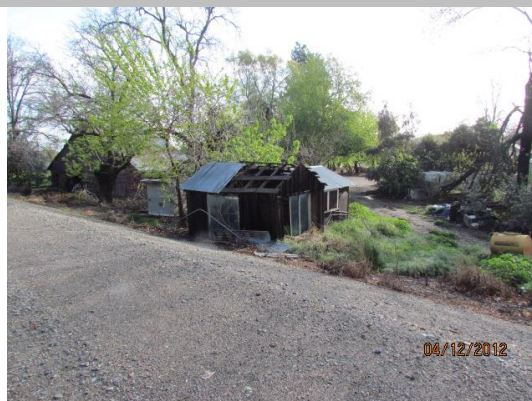
Photo 1 of 1 : FA_2018_ST0003_264_2_20180905_00002.jpg

LM Start	8.75	Rating **	U	Issue No.	2
LM End	8.75	Issue Type +	En	Location *	LS
Category	Earthen Levee			GPS Latitude/Longitude	
				Start	End
Item	Encroachments			39.252260 °	39.252260 °
				-121.997721 °	-121.997721 °
DWR ID	DWR_ST0003_01_s_2012_2				
Comment Code					
BU : Building					
Inspector Comment

View of the building next to the toe of the levee.

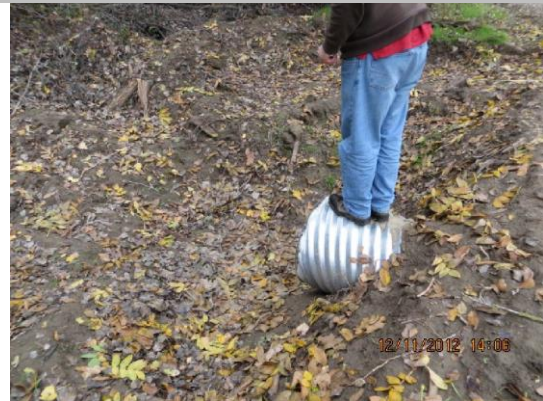
Photo 2 of 3 : UCIP_FA_2018_51731_47241.jpg

Waterside view: overview of CMP pipe

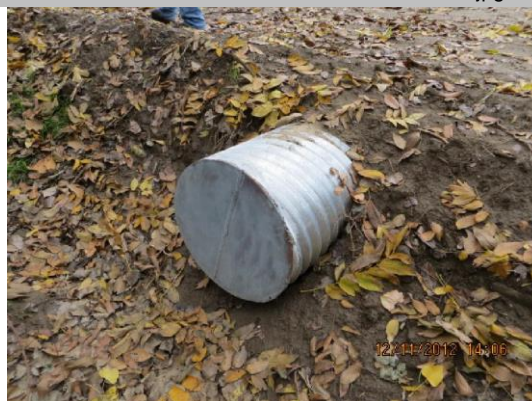
Photo 3 of 3 : UCIP_FA_2018_51731_47240.jpg

FIELD_STRUCT_DESC: *ABANDONED* 24-inch corrugated metal drainage pipe through the levee, 13.5 feet below the crown. Slide gate on the landside (LS) headwall. Steel plate welded on the waterside (WS) end. [Additional Reference(s): DWR Levee Log, 2002. USACE Sacramento O&M Manual 136, March 1960 (HLM 9.4)].						
FS Date: 5/1/2017 9:16:26 AM

Waterside view: capped CMP pipe

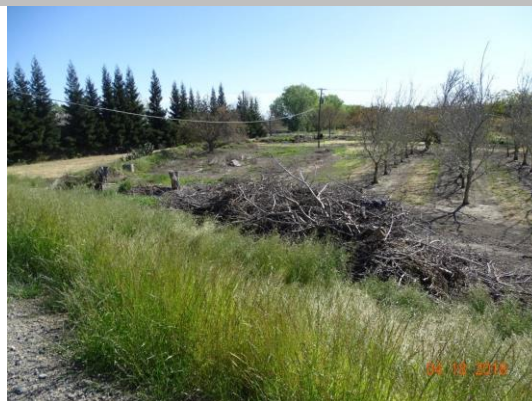
Photo 1 of 1 : FA_2018_ST0003_264_113_20180905_00027.jpg

LM Start	9.74	Rating **	M	Issue No.	113	
LM End	9.74	Issue Type +	En	Location *	LS	
Category	Earthen Levee			GPS Latitude/Longitude		
				Start		End
Item	Encroachments			39.264740 °		39.264740 °
				-121.998288 °		-121.998288 °
DWR ID	DWR_ST0003_01_s_2018_113					
Comment Code						
PR : Prunings						
Inspector Comment						
Remove the prunings from the landside toe.

View of the prunings along the landside toe.

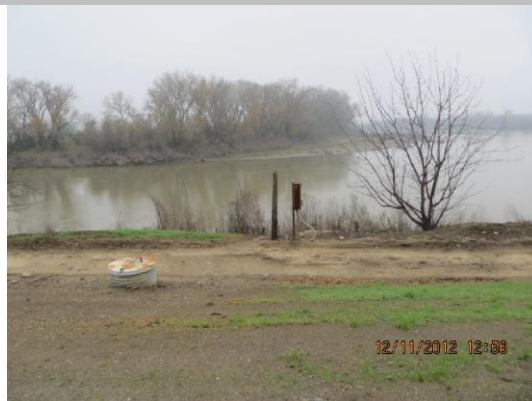
Photo 1 of 3 : UCIP_FA_2018_51735_47270.jpg

Comment Code					
Inspector Comment					
FS_ID:51735 DS_ID:17371 EP_NO: 9517 Repair Type: Non-Urgent Crossing Status: Found UCIP Comments: 4/19/2017 Abandoned- needs to be done so properly. (DWR Sutter Yard- Afreitag)10/31/2016 Abandoned. (DWR Sutter Yard- Afreitag)6/1/2016 Abandoned crossing.4/2/2015 Same as last inspection. Need to verify type of abandonment. Pump house not found on waterside of the levee. Looks abandoned as switch panel found without pump.6/30/2014 Same as last inspection.12/18/2013 Same as last inspection.7/23/2013 Same as last inspection. FIELD_STRUCT_DESC: *ABANDONED* 18-inch steel irrigation pipe through the levee, 17.1 feet below the crown. Gate valve and flap gate in a concrete distribution box. Water meter in a corrugated metal pipe (CMP) riser at the landside (LS) toe. Gate valve in a CMP on the waterside (WS). Pipe was replaced in November 2005. (Automatic Board Order (ABO) issued as Permit No. 9517, 1974 - Griffin). [Additional Reference(s): DWR Levee Log, 2002. USACE Sacramento O&M Manual 136, March 1960 (HLM 10.53)]. FS Date: 5/1/2017 9:39:39 AM

Waterside view: CMP riser and abandoned service pole

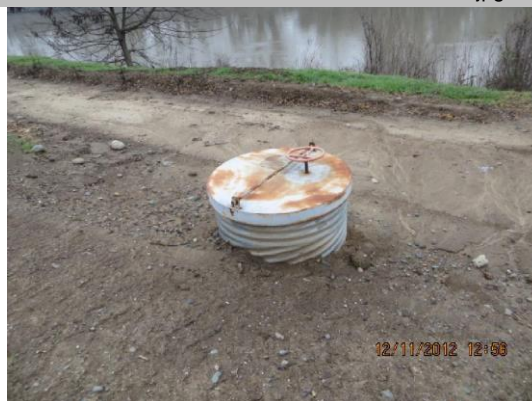
Photo 2 of 3 : UCIP_FA_2018_51735_47269.jpg

FS_ID:51735
DS_ID:17371
EP_NO: 9517
Repair Type: Non-Urgent
Crossing Status: Found
UCIP Comments: 4/19/2017 Abandoned- needs to be done so properly. (DWR Sutter Yard- Afreitag)10/31/2016 Abandoned. (DWR Sutter Yard- Afreitag)6/1/2016 Abandoned crossing.4/2/2015 Same as last inspection. Need to verify type of abandonment. Pump house not found on waterside of the levee. Looks abandoned as switch panel found without pump.6/30/2014 Same as last inspection.12/18/2013 Same as last inspection.7/23/2013 Same as last inspection.
FIELD_STRUCT_DESC: *ABANDONED* 18-inch steel irrigation pipe through the levee, 17.1 feet below the crown. Gate valve and flap gate in a concrete distribution box. Water meter in a corrugated metal pipe (CMP) riser at the landside (LS) toe. Gate valve in a CMP on the waterside (WS). Pipe was replaced in November 2005. (Automatic Board Order (ABO) issued as Permit No. 9517, 1974 - Griffin).

Waterside view: CMP riser with gate valve

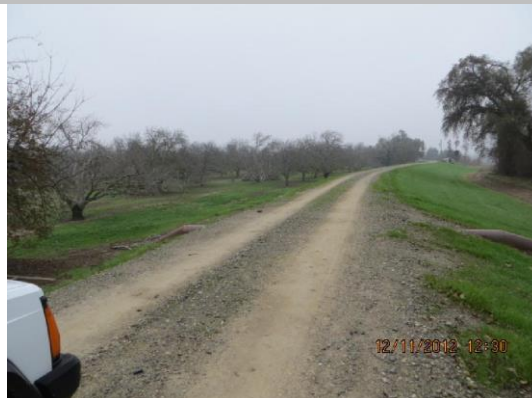
Photo 1 of 3 : UCIP_FA_2018_51737_47284.jpg

Comment Code					
Inspector Comment					
FS_ID:51737 DS_ID:17350 EP_NO: 1369 Repair Type: Non-Urgent Crossing Status: Found UCIP Comments: 4/19/2017 Abandoned- needs to be done so properly. (DWR Sutter Yard- A Freitag)10/31/2016 Appears abandoned. (DWR Sutter Yard- A Freitag)6/1/2016 Appears to be an abandoned crossing.4/2/2015 Same as last inspection. Looks abandoned and if so should be done so properly. Pump and switch panel not found. Outlet pipe blocked by silt and debris.6/30/2014 Same as last inspection.12/18/2013 Same as last inspection.7/23/2013 Same as last inspection. FIELD_STRUCT_DESC: *ABANDONED* 24-inch steel irrigation pipe through the levee, 4 feet below the crown. Siphon breaker on the landside (LS) slope. Concrete distribution box on the LS toe. (Permit No. 1369, 1949 - Griffin). [Additional Reference(s): DWR Levee Log, 2002. USACE Sacramento O&M Manual 136, March 1960 (HLM 10.68)]. FS Date: 5/1/2017 9:44:43 AM

Crown view: overview (both sides of the levee)

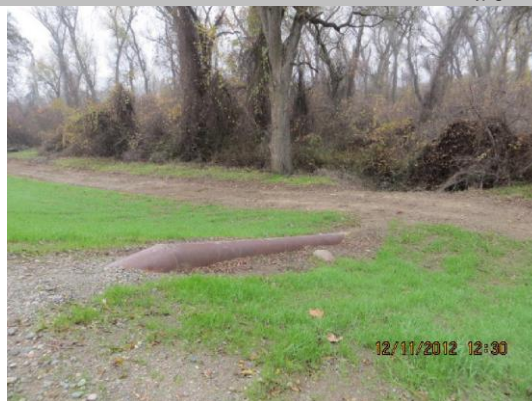
Photo 2 of 3 : UCIP_FA_2018_51737_47283.jpg

Waterside view: overview of exposed steel pipe

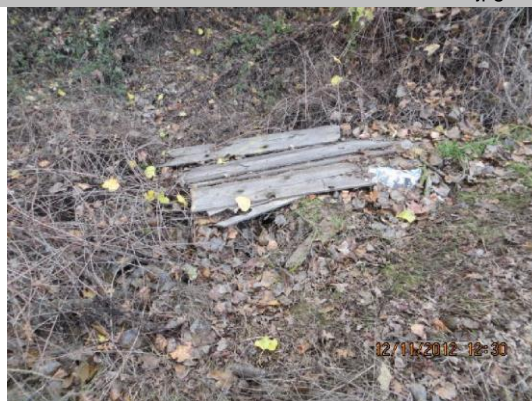
Photo 3 of 3 : UCIP_FA_2018_51737_47287.jpg

FS_ID:51737
DS_ID:17350
EP_NO: 1369
Repair Type: Non-Urgent
Crossing Status: Found
UCIP Comments: 4/19/2017 Abandoned- needs to be done so properly. (DWR Sutter Yard- AFreitag)10/31/2016 Appears abandoned. (DWR Sutter Yard- AFreitag)6/1/2016 Appears to be an abandoned crossing.4/2/2015 Same as last inspection. Looks abandoned and if so should be done so properly. Pump and switch panel not found. Outlet pipe blocked by silt and debris.6/30/2014 Same as last inspection.12/18/2013 Same as last inspection.7/23/2013 Same as last inspection.
FIELD_STRUCT_DESC: *ABANDONED* 24-inch steel irrigation pipe through the levee, 4 feet below the crown. Siphon breaker on the landside (LS) slope. Concrete distribution box on the LS toe. (Permit No. 1369, 1949 - Griffin). [Additional Reference(s): DWR Levee Log, 2002. USACE Sacramento O&M Manual 136, March 1960 (HLM 10.68)].
FS Date: 5/1/2017 9:44:43 AM

Waterside view: beyond exposed steel pipe (not accessible)

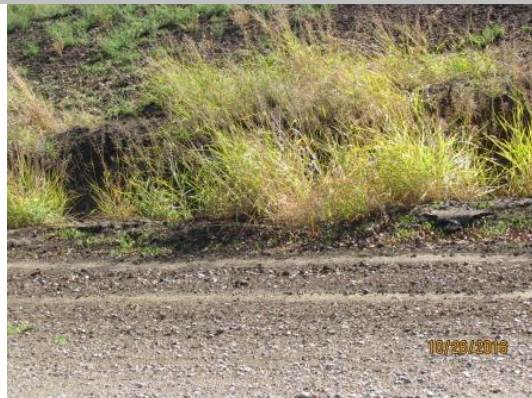
Photo 1 of 1 : FA_2018_ST0003_264_6_20180905_00004.jpg

LM Start	11.67	Rating **	M	Issue No.	6
LM End	11.90	Issue Type +	En	Location *	LS
Category	Earthen Levee			GPS Latitude/Longitude	
				Start	End
Item	Encroachments			39.282064 °	39.285084 °
				-122.016517 °	-122.014815 °
DWR ID	DWR_ST0003_01_s_2012_6				
Comment Code					
DT : Ditch					
Inspector Comment

View of the ditch along the landside toe.

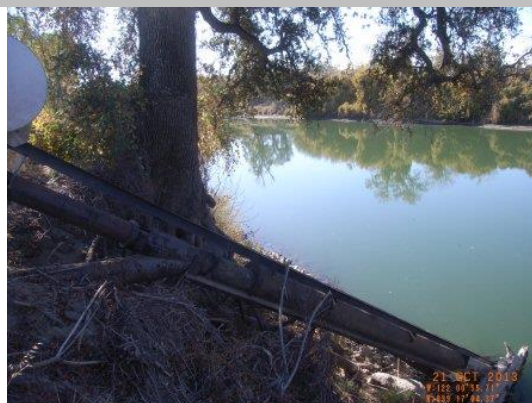
Photo 1 of 1 : FA_2018_ST0003_264_13_20180905_00010.jpg

LM Start	11.85	Rating **	M	Issue No.	13
LM End	11.90	Issue Type +	Ma	Location *	WS
Category	Supplemental			GPS Latitude/Longitude	
				Start	End
Item	2017 USACE Erosion Survey, DRAFT			39.284568 °	39.285298 °
				-122.015690 °	-122.015208 °
DWR ID	DWR_ST0003_01_f_2018_13				
Comment Code					
Inspector Comment					
2017 Site ID: SAC 152.8 L					
Status: Eroding					
2017 Field Notes: Minor new erosion observed.					
Site History: 2006 - Large rotational/mass failure in the bank with tree slump. Tough clayey toe material. 2007 - Site is between stone revetments with a pump station at the downstream end. 2010 - Erosion is into the levee toe. 2011 - Minor new erosion. 2012 - Minor new erosion.

USACE 2013 Photo #1

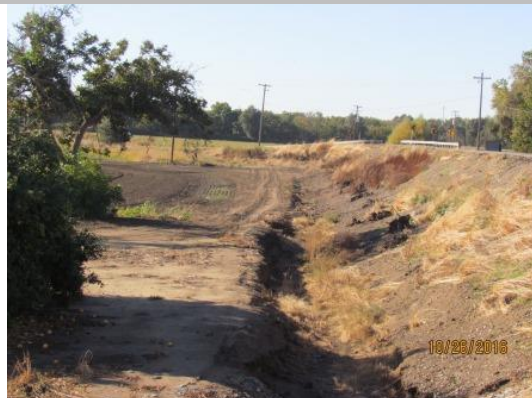
Photo 1 of 1 : FA_2018_ST0003_264_7_20180905_00005.jpg

LM Start	11.94	Rating **	M	Issue No.	7
LM End	12.18	Issue Type +	En	Location *	LS
Category	Earthen Levee			GPS Latitude/Longitude	
				Start	End
Item	Encroachments			39.285658 °	39.288978 °
				-122.014574 °	-122.013892 °
DWR ID	DWR_ST0003_01_s_2012_7				
Comment Code					
DT : Ditch					
Inspector Comment

View of the ditch along the landside toe.

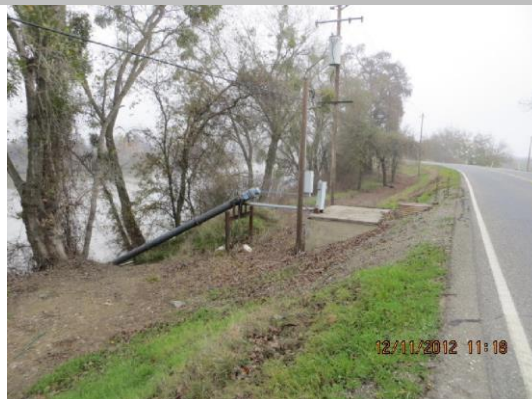
Photo 1 of 3 : UCIP_FA_2018_51743_47306.jpg

Comment Code					
Inspector Comment					
FS_ID:51743 DS_ID:17365 EP_NO: 9514 Repair Type: Non-Urgent Crossing Status: Found UCIP Comments: 4/19/2017 Crossing appears to be in good condition. (DWR Sutter Yard- Afreitag)10/31/2016 Crossing appears to be in good condition.(DWR Sutter Yard- Afreitag)6/6/2016 Crossing appears to be in good condition. New wooden cover was made for WS surge tank.4/2/2015 Everything looked to be in good condition. Concrete surge tank still has some silting. Gate valve in CMP riser not visible. Flap gate in concrete distribution box on LS not visible/accessible. Looks like cleaning required inside concrete surge tank on WS due to silting.7/2/2014 Same as last inspection.12/30/2013 Same as last inspection.7/29/2013 Pump running and WS surge tank was full of water so not sure if silt was cleaned out. LS flap gate was visible and is in good condition. FIELD_STRUCT_DESC: 36-inch corrugated metal irrigation pipe through the levee, 18.1 feet below the crown. Pump house on the waterside (WS) slope. Gate valve in a corrugated metal riser on the WS toe. Flap gate in a concrete distribution box at the landside (LS) toe. (Automatic Board Order (ABO) issued as Permit No. 9514, 1974 - Boggs). [Additional Reference(s): Levee Log, 2002. USACE Sacramento O&M Manual 136, March 1960 (HLM 12.05)]. FS Date: 5/1/2017 9:57:28 AM

Waterside view: overview pipe, pump, surge box & CMP riser

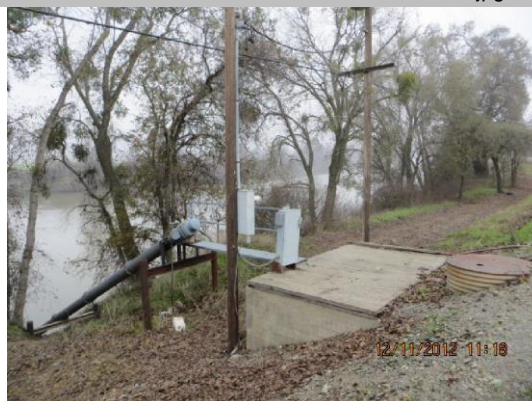
Photo 2 of 3 : UCIP_FA_2018_51743_47305.jpg

FS_ID:51743
DS_ID:17365
EP_NO: 9514
Repair Type: Non-Urgent
Crossing Status: Found
UCIP Comments: 4/19/2017 Crossing appears to be in good condition.
(DWR Sutter Yard- AFreitag)10/31/2016 Crossing appears to be in good condition.(DWR Sutter Yard- AFreitag)6/6/2016 Crossing appears to be in good condition. New wooden cover was made for WS surge tank.4/2/2015 Everything looked to be in good condition. Concrete surge tank still has some silting. Gate valve in CMP riser not visible. Flap gate in concrete distribution box on LS not visible/accessible. Looks like cleaning required inside concrete surge tank on WS due to silting.7/2/2014 Same as last inspection.12/30/2013 Same as last inspection.7/29/2013 Pump running and WS surge tank was full of water so not sure if silt was cleaned out. LS flap gate was visible and is in good condition. FIELD_STRUCT_DESC: 36-inch corrugated metal irrigation pipe through the levee, 18.1 feet below the crown. Pump house on the waterside (WS) slope. Gate valve in a corrugated metal riser on the WS toe. Flap gate in a concrete distribution box at the landside (LS) toe. (Automatic Board Order (ABO) issued as Permit No. 9514, 1974 - Boggs). [Additional Reference(s): Levee Log, 2002. USACE Sacramento O&M Manual 136, March 1960 (HLM 12.05)]. FS Date: 5/1/2017 9:57:28 AM

Waterside view: steel pipe, pump, surge box & CMP riser

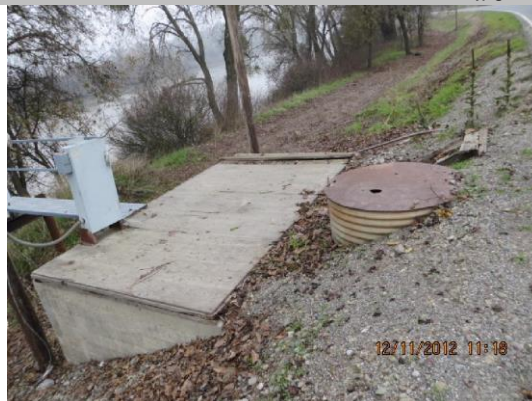
Photo 3 of 3 : UCIP_FA_2018_51743_47304.jpg

Waterside view: pump switch box, surge box & CMP riser

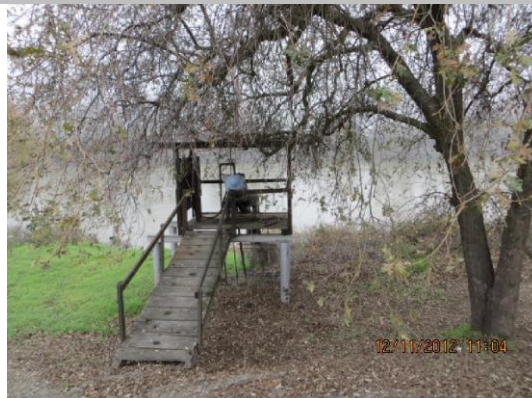
Photo 1 of 3 : UCIP_FA_2018_51744_47313.jpg

FS_ID:51744
DS_ID:17366
EP_NO: 9513
Repair Type: Non-Urgent
Crossing Status: Found
UCIP Comments: 4/20/2017 2.5in. GI pipe was removed and replaced with a section of 2.5in. flexible hose that can easily be removed to allow the slide gate to fully close for high water season. (DWR Sutter Yard- Afreitag)10/31/2016 2.5in. pipe still blocking the screwgate. (DWR Sutter Yard- Afreitag)6/6/2016 2.5inch pipe still present through crossing. (DWR Sutter Yard - afreitag)4/14/2016 2.5-inch pipe still preventing slide gate from fully closing on WS. Recommend LMA contact owner to address removal of unauthorized 2.5-inch pipe. Owner must either contact CVFPB for permitting of 2.5-inch pipe or remove it. (DWR UCIP - kfazel)4/2/2015 2.5in pipe is still present and prevents the slide gate from fully closing. (DWR Sutter Yard - afreitag)7/2/2014 2.5in. GI pipe and chain in WS surge box will prevent slide gate from closing fully for high water season. (DWR Sutter Yard - afreitag)12/30/2013 Same as last inspection. (DWR Sutter Yard - afreitag)7/29/2013 2.5in. GI pipe and chain in WS surge box will prevent slide gate from closing fully for high water season. (DWR Sutter Yard - afreitag)12/11/2012 A 2.5 inch GI pipe through 36 inch CMP found. A 2 inch electrical conduit also found. (DWR UCIP - pamatya)

FIELD_STRUCT_DESC: 24-inch corrugated metal irrigation pipe through the levee, invert 16.5 feet below the crown. Slide gate in a concrete surge box on the waterside (WS) berm. 2.5-inch pipe through the 24-inch pipe preventing closing of the slide gate on the WS. Slant pump on the riverbank. Concrete distribution box at the landside (LS) toe. 2-inch electrical conduit through the levee, visible on the WS adjacent to the walkway. (Automatic Board Order (ABO) issued as Permit No. 9513, 1974 - Boggs). [Additional Reference(s): DWR Levee Log, 2002. USACE Sacramento O&M Manual 136, March 1960 (HLM 12.42)].
FS Date: 5/1/2017 9:58:54 AM

Waterside view: overview of slanted pump and shed

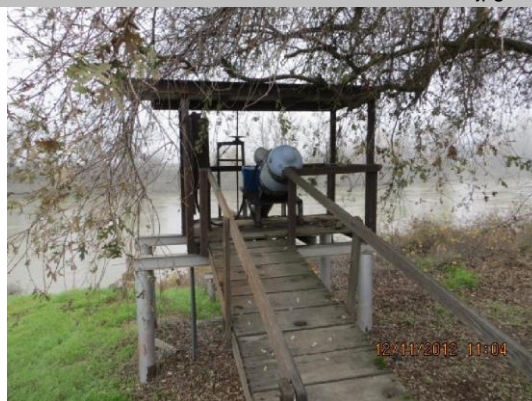
Photo 2 of 3 : UCIP_FA_2018_51744_47312.jpg

FS_ID:51744
DS_ID:17366
EP_NO: 9513
Repair Type: Non-Urgent
Crossing Status: Found
UCIP Comments: 4/20/2017 2.5in. GI pipe was removed and replaced with a section of 2.5in. flexible hose that can easily be removed to allow the slide gate to fully close for high water season. (DWR Sutter Yard- Afreitag)10/31/2016 2.5in. pipe still blocking the screwgate. (DWR Sutter Yard- Afreitag)6/6/2016 2.5inch pipe still present through crossing. (DWR Sutter Yard - afreitag)4/14/2016 2.5-inch pipe still preventing slide gate from fully closing on WS. Recommend LMA contact owner to address removal of unauthorized 2.5-inch pipe. Owner must either contact CVFPB for permitting of 2.5-inch pipe or remove it. (DWR UCIP - kfazel)4/2/2015 2.5in pipe is still present and prevents the slide gate from fully closing. (DWR Sutter Yard - afreitag)7/2/2014 2.5in. GI pipe and chain in WS surge box will prevent slide gate from closing fully for high water season. (DWR Sutter Yard - afreitag)12/30/2013 Same as last inspection. (DWR Sutter Yard - afreitag)7/29/2013 2.5in. GI pipe and chain in WS surge box will prevent slide gate from closing fully for high water season. (DWR Sutter Yard - afreitag)12/11/2012 A 2.5 inch GI pipe through 36 inch CMP found. A 2 inch electrical conduit also found. (DWR UCIP - pamatya)

Waterside view: pump station and walkway

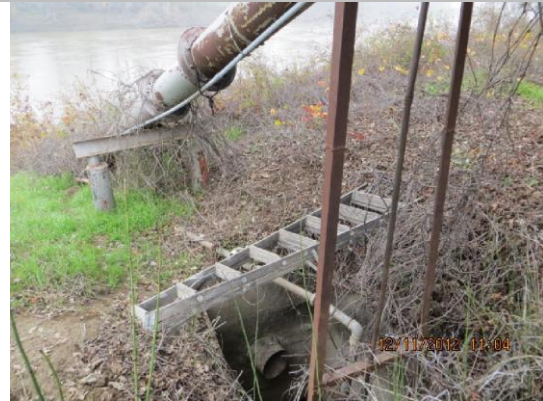
Photo 3 of 3 : UCIP_FA_2018_51744_47311.jpg

FS_ID:51744
 DS_ID:17366
 EP_NO: 9513
 Repair Type: Non-Urgent
 Crossing Status: Found
 UCIP Comments: 4/20/2017 2.5in. GI pipe was removed and replaced with a section of 2.5in. flexible hose that can easily be removed to allow the slide gate to fully close for high water season. (DWR Sutter Yard- Afreitag)10/31/2016 2.5in. pipe still blocking the screwgate. (DWR Sutter Yard- Afreitag)6/6/2016 2.5inch pipe still present through crossing. (DWR Sutter Yard - afreitag)4/14/2016 2.5-inch pipe still preventing slide gate from fully closing on WS. Recommend LMA contact owner to address removal of unauthorized 2.5-inch pipe. Owner must either contact CVFPB for permitting of 2.5-inch pipe or remove it. (DWR UCIP - kfazel)4/2/2015 2.5in pipe is still present and prevents the slide gate from fully closing. (DWR Sutter Yard - afreitag)7/2/2014 2.5in. GI pipe and chain in WS surge box will prevent slide gate from closing fully for high water season. (DWR Sutter Yard - afreitag)12/30/2013 Same as last inspection. (DWR Sutter Yard - afreitag)7/29/2013 2.5in. GI pipe and chain in WS surge box will prevent slide gate from closing fully for high water season. (DWR Sutter Yard - afreitag)12/11/2012 A 2.5 inch GI pipe through 36 inch CMP found. A 2 inch electrical conduit also found. (DWR UCIP - pamatya)

FIELD_STRUCT_DESC: 24-inch corrugated metal irrigation pipe through the levee, invert 16.5 feet below the crown. Slide gate in a concrete surge box on the waterside (WS) berm. 2.5-inch pipe through the 24-inch pipe preventing closing of the slide gate on the WS. Slant pump on the riverbank. Concrete distribution box at the landside (LS) toe. 2-inch electrical conduit through the levee, visible on the WS adjacent to the walkway. (Automatic Board Order (ABO) issued as Permit No. 9513, 1974 - Boggs). [Additional Reference(s): DWR Levee Log, 2002. USACE Sacramento O&M Manual 136, March 1960 (HLM 12.42)].
 FS Date: 5/1/2017 9:58:54 AM

Waterside view: steel pipe, GI pipe in concrete surge box

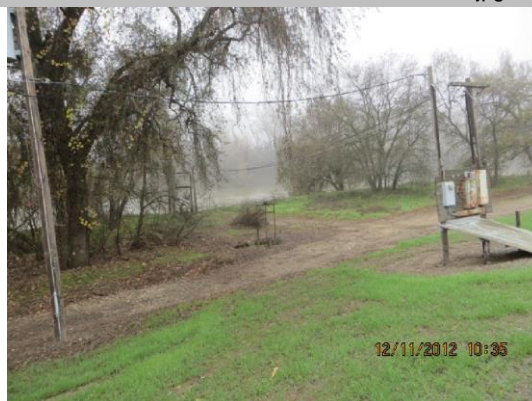
Photo 1 of 3 : UCIP_FA_2018_53403_47323.jpg

UCIP Comments: 8/30/2018 Same as last inspection; large sink hole/erosion around surge box on WS so crossing remains Urgent (D. Sanoski - DWR UCIP).4/20/2017 Sink hole behind the WS surge box got a lot bigger after the high water event of Jan/Feb 2017. Pipe also had a leak during that time but not sure if it was due to the sink hole or a faulty slide gate. (DWR Sutter Yard- AFreitag)10/31/2016 No repairs have been made here yet. Sinkhole is still present at the WS surge box.(DWR Sutter Yard- AFreitag)6/6/2016 Pumps were connected to intake pipes and pumping into the WS surge box. The deep sink hole above the surge box measures to be about 6'6" deep from the toe road surface and it appeared to be wet in the bottom indicating the cracks in the concrete may be letting water seep through and wash out the sediment behind the wall. The surge box was full of water so could not observe the sediment build up in the bottom of the box. (DWR Sutter Yard - afreitag)4/14/2016 Deep sink hole above surge box on WS, possibly caused by burrowing, possibly creating conduit for seepage into surge box, which may explain presence of water in box. Recommend pipe be video inspected. Recommend taking another photo in summer to observe possible sediment buildup in box. (DWR UCIP - kfazel)4/2/2015 Pipe has small leak during times of high water. Not sure of the cause. Pumps taken out from the pipe (may be for repairs). Only control board found. LS wing wall minor damage. (DWR Sutter Yard - afreitag)7/2/2014 Same as last inspection. (DWR Sutter Yard - afreitag)12/19/2013 Same as last inspection. (DWR Sutter Yard - afreitag)7/23/2013 Pump motors attached to pipes and running. Think pumps were disconnected during last inspection to keep motors above water for high water season. (DWR Sutter Yard - afreitag)12/11/2012 Pumps taken out from the pipe (may be for repairs). Only control board found. LS wing wall minor damage. (DWR UCIP - pamatya)

Waterside view: overview

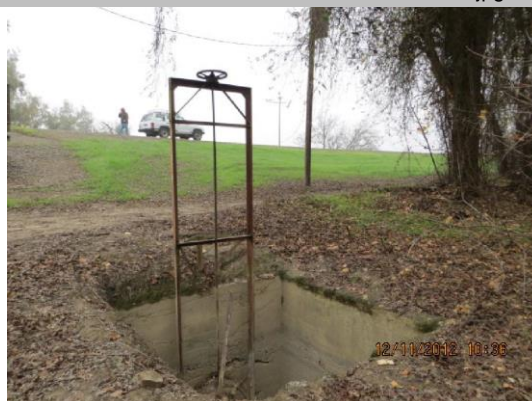
Photo 2 of 3 : UCIP_FA_2018_53403_47322.jpg

UCIP Comments: 8/30/2018 Same as last inspection; large sink hole/erosion around surge box on WS so crossing remains Urgent (D. Sanoski - DWR UCIP).4/20/2017 Sink hole behind the WS surge box got a lot bigger after the high water event of Jan/Feb 2017. Pipe also had a leak during that time but not sure if it was due to the sink hole or a faulty slide gate. (DWR Sutter Yard- AFreitag)10/31/2016 No repairs have been made here yet. Sinkhole is still present at the WS surge box.(DWR Sutter Yard- AFreitag)6/6/2016 Pumps were connected to intake pipes and pumping into the WS surge box. The deep sink hole above the surge box measures to be about 6'6" deep from the toe road surface and it appeared to be wet in the bottom indicating the cracks in the concrete may be letting water seep through and wash out the sediment behind the wall. The surge box was full of water so could not observe the sediment build up in the bottom of the box. (DWR Sutter Yard - afreitag)4/14/2016 Deep sink hole above surge box on WS, possibly caused by burrowing, possibly creating conduit for seepage into surge box, which may explain presence of water in box. Recommend pipe be video inspected. Recommend taking another photo in summer to observe possible sediment buildup in box. (DWR UCIP - kfazel)4/2/2015 Pipe has small leak during times of high water. Not sure of the cause. Pumps taken out from the pipe (may be for repairs). Only control board found. LS wing wall minor damage. (DWR Sutter Yard - afreitag)7/2/2014 Same as last inspection. (DWR Sutter Yard - afreitag)12/19/2013 Same as last inspection. (DWR Sutter Yard - afreitag)7/23/2013 Pump motors attached to pipes and running. Think pumps were disconnected during last inspection to keep motors above water for high water season. (DWR Sutter Yard - afreitag)12/11/2012 Pumps taken out from the pipe (may be for repairs). Only control board found. LS wing wall minor damage. (DWR UCIP - pamatya)

Waterside view: concrete surge box

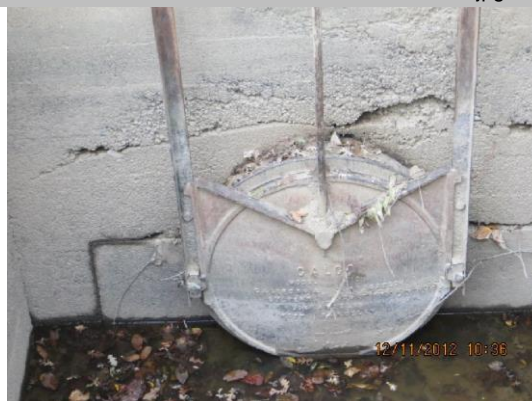
Photo 3 of 3 : UCIP_FA_2018_53403_47321.jpg

UCIP Comments: 8/30/2018 Same as last inspection; large sink hole/erosion around surge box on WS so crossing remains Urgent (D. Sanoski - DWR UCIP).4/20/2017 Sink hole behind the WS surge box got a lot bigger after the high water event of Jan/Feb 2017. Pipe also had a leak during that time but not sure if it was due to the sink hole or a faulty slide gate. (DWR Sutter Yard- AFreitag)10/31/2016 No repairs have been made here yet. Sinkhole is still present at the WS surge box.(DWR Sutter Yard- AFreitag)6/6/2016 Pumps were connected to intake pipes and pumping into the WS surge box. The deep sink hole above the surge box measures to be about 6'6" deep from the toe road surface and it appeared to be wet in the bottom indicating the cracks in the concrete may be letting water seep through and wash out the sediment behind the wall. The surge box was full of water so could not observe the sediment build up in the bottom of the box. (DWR Sutter Yard - afreitag)4/14/2016 Deep sink hole above surge box on WS, possibly caused by burrowing, possibly creating conduit for seepage into surge box, which may explain presence of water in box. Recommend pipe be video inspected. Recommend taking another photo in summer to observe possible sediment buildup in box. (DWR UCIP - kfazel)4/2/2015 Pipe has small leak during times of high water. Not sure of the cause. Pumps taken out from the pipe (may be for repairs). Only control board found. LS wing wall minor damage. (DWR Sutter Yard - afreitag)7/2/2014 Same as last inspection. (DWR Sutter Yard - afreitag)12/19/2013 Same as last inspection. (DWR Sutter Yard - afreitag)7/23/2013 Pump motors attached to pipes and running. Think pumps were disconnected during last inspection to keep motors above water for high water season. (DWR Sutter Yard - afreitag)12/11/2012 Pumps taken out from the pipe (may be for repairs). Only control board found. LS wing wall minor damage. (DWR UCIP - pamatya)

Waterside view: slide gate in concrete surge box

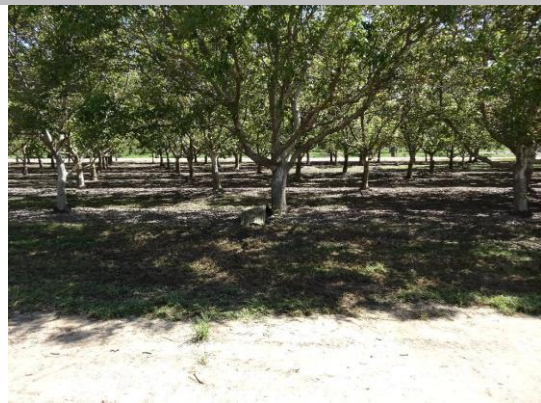
Photo 1 of 3 : UCIP_FA_2018_51747_75075.jpg

Comment Code					
Inspector Comment					
FS_ID:51747 DS_ID:17368 EP_NO: N/A Repair Type: Non-Urgent Crossing Status: Indicator Found UCIP Comments: 4/20/2017 Abandoned- needs to be done properly. (DWR Sutter Yard- A Freitag)10/31/2016 Appears abandoned. (DWR Sutter Yard- A Freitag)6/14/2016 Pipe was internally cleaned and camera inspected on 11/5/2015 by Nor-Cal Pipeline Services. Pipe length is 86.7ft long. The is a possible sag in the pipe between the WS riser and LS end as we could not get all the water to drain or be sucked out after the cleaning was done. Internal inspection showed signs of some rusting but no visible holes or other deterioration were found. After the inspection pipe ends were capped and reburied. 4/14/2016 Same as last inspection. Heavy vegetation along WS slope, especially below WS berm, limits visibility.4/2/2015 WS and LS pipe ends have been dug up in preparation for internal camera inspections. Only CMP riser found.7/2/2014 Same as last inspection.12/19/2013 Same as last inspection.7/23/2013 Same as last inspection. FIELD_STRUCT_DESC: *ABANDONED* 12-inch drainage pipe of an unknown material through the levee, 14 feet below the crown, not found in 2016. Slide gate in a corrugated metal pipe riser (CMP) on the waterside (WS) slope, found in 2016. [Additional Reference(s): DWR Levee Log, 2002. USACE Sacramento O&M Manual 136, March 1960 (HLM 12.73)]. FS Date: 5/1/2017 10:19:49 AM

View of landside from crown.

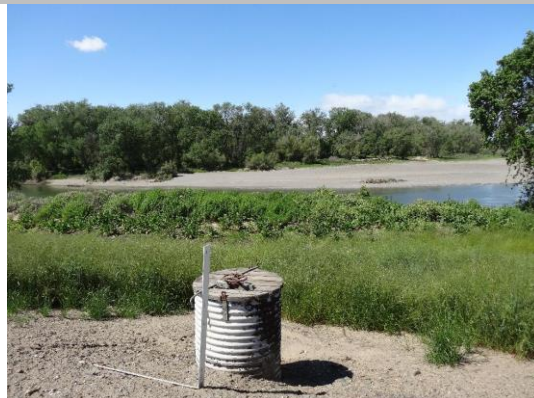
Photo 2 of 3 : UCIP_FA_2018_51747_75076.jpg

WS view: 12-inch slide gate inside CMP riser on WS slope.

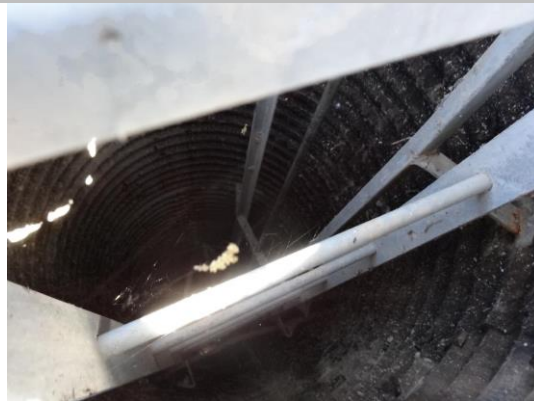
Photo 3 of 3 : UCIP_FA_2018_51747_75077.jpg

WS: slide gate inside CMP riser.

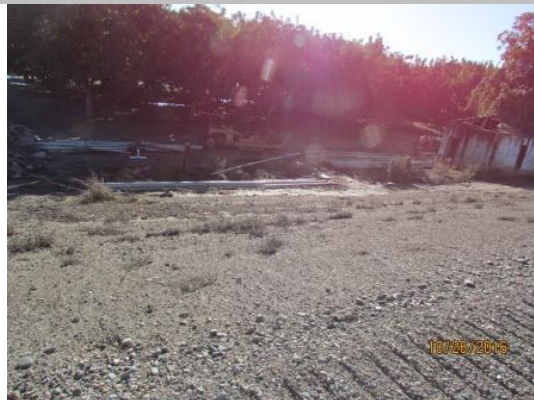
Photo 1 of 1 : FA_2018_ST0003_264_76_20180905_00017.jpg

LM Start	12.85	Rating **	M	Issue No.	76
LM End	12.85	Issue Type +	En	Location *	LS
Category	Earthen Levee			GPS Latitude/Longitude	
				Start	End
Item	Encroachments			39.298582°	39.298582°
				-122.014105°	-122.014105°
DWR ID	DWR_ST0003_01_f_2016_76				
Comment Code					
EQ : Equipment					
Inspector Comment

View of the ag equipment along the landside toe.

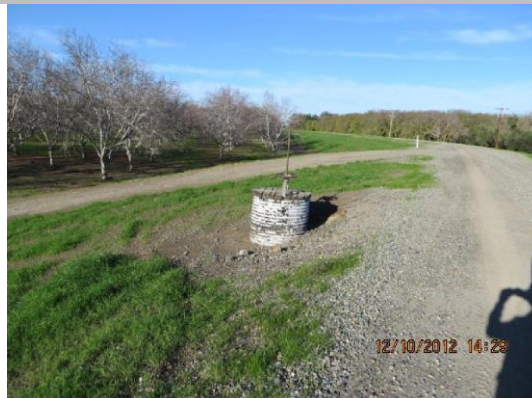
Photo 1 of 3 : UCIP_FA_2018_53404_47336.jpg

FS_ID:53404
DS_ID:17369
EP_NO: 9510
Repair Type: Urgent
Crossing Status: Found
UCIP Comments: 8/30/2018 Same as last inspection; erosion at surge box so crossing remains Urgent (D. Sanoski - DWR UCIP).4/20/2017 Erosion hole at WS surge box has gotten worse after the Jan/Feb 2017 high water event. Pipe also leaked which is believed to be caused by the screwgate not fully closing. (DWR Sutter Yard-afreitag)10/31/2016 No repairs have been made here yet. Bad erosion still present at the WS toe distribution box.(DWR Sutter Yard-afreitag)6/3/2016 Bad erosion still present all around the WS surge box. Pipes were flowing water at the time of inspection and the bottom of the erosion hole was wet and had standing water in it indicating a leak coming from the surge box. (DWR Sutter Yard -afreitag)4/14/2016 Heavy scour still present around surge box on WS exposing pipe. Levee caved in and severely damaged around surge box. Erosion around CMP riser on WS cited previously not found. (DWR UCIP - kfazel)4/2/2015 Pipe leaks during high water. It is suspected that the screw gate does not fully close and may need to be cleaned to allow it to close fully. (DWR Sutter Yard - afreitag)7/2/2014 Same as last inspection. (DWR Sutter Yard - afreitag)12/19/2013 Same as last inspection. (DWR Sutter Yard - afreitag)7/23/2013 Water was flowing from the WS to LS ditch. Not sure where water flow was originating. All erosion problems are still present. (DWR Sutter Yard - afreitag)12/10/2016 Soil erosion around CMP riser and surge concrete box on WS damaged due to overflow. Pump not found. Flap gate missing on WS concrete box. WS slope eroded. Structure might have been used as drainage structure. This needs to be determined during routine inspection. (DWR UCIP - pamatya)

Waterside view: CMP riser on levee slope.

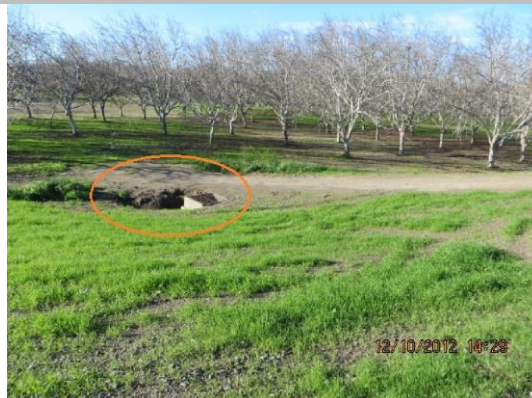
Photo 2 of 3 : UCIP_FA_2018_53404_47334.jpg

UCIP Comments: 8/30/2018 Same as last inspection; erosion at surge box so crossing remains Urgent (D. Sanoski - DWR UCIP). 4/20/2017 Erosion hole at WS surge box has gotten worse after the Jan/Feb 2017 high water event. Pipe also leaked which is believed to be caused by the screwgate not fully closing. (DWR Sutter Yard - afreitag)10/31/2016 No repairs have been made here yet. Bad erosion still present at the WS toe distribution box. (DWR Sutter Yard - afreitag)6/3/2016 Bad erosion still present all around the WS surge box. Pipes were flowing water at the time of inspection and the bottom of the erosion hole was wet and had standing water in it indicating a leak coming from the surge box. (DWR Sutter Yard - afreitag)4/14/2016 Heavy scour still present around surge box on WS exposing pipe. Levee caved in and severely damaged around surge box. Erosion around CMP riser on WS cited previously not found. (DWR UCIP - kfazel)4/2/2015 Pipe leaks during high water. It is suspected that the screw gate does not fully close and may need to be cleaned to allow it to close fully. (DWR Sutter Yard - afreitag)7/2/2014 Same as last inspection. (DWR Sutter Yard - afreitag)12/19/2013 Same as last inspection. (DWR Sutter Yard - afreitag)7/23/2013 Water was flowing from the WS to LS ditch. Not sure where water flow was originating. All erosion problems are still present. (DWR Sutter Yard - afreitag)12/10/2016 Soil erosion around CMP riser and surge concrete box on WS damaged due to overflow. Pump not found. Flap gate missing on WS concrete box. WS slope eroded. Structure might have been used as drainage structure. This needs to be determined during routine inspection. (DWR UCIP - pamatya)

Waterside view: overview of concrete surge box

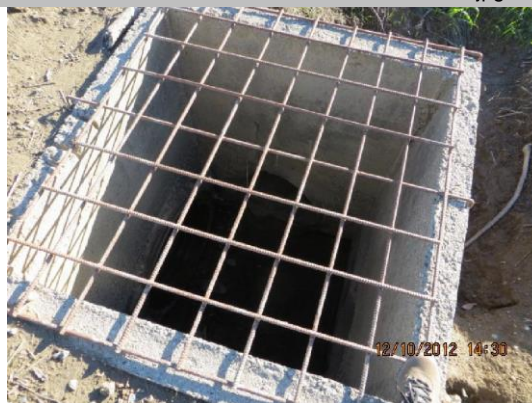
Photo 3 of 3 : UCIP_FA_2018_53404_47333.jpg

FS_ID:53404
DS_ID:17369
EP_NO: 9510
Repair Type: Urgent
Crossing Status: Found
UCIP Comments: 8/30/2018 Same as last inspection; erosion at surge box so crossing remains Urgent (D. Sanoski - DWR UCIP).4/20/2017 Erosion hole at WS surge box has gotten worse after the Jan/Feb 2017 high water event. Pipe also leaked which is believed to be caused by the screwgate not fully closing. (DWR Sutter Yard-afreitag)10/31/2016 No repairs have been made here yet. Bad erosion still present at the WS toe distribution box.(DWR Sutter Yard-afreitag)6/3/2016 Bad erosion still present all around the WS surge box. Pipes were flowing water at the time of inspection and the bottom of the erosion hole was wet and had standing water in it indicating a leak coming from the surge box. (DWR Sutter Yard -afreitag)4/14/2016 Heavy scour still present around surge box on WS exposing pipe. Levee caved in and severely damaged around surge box. Erosion around CMP riser on WS cited previously not found. (DWR UCIP - kfazel)4/2/2015 Pipe leaks during high water. It is suspected that the screw gate does not fully close and may need to be cleaned to allow it to close fully. (DWR Sutter Yard - afreitag)7/2/2014 Same as last inspection. (DWR Sutter Yard - afreitag)12/19/2013 Same as last inspection. (DWR Sutter Yard - afreitag)7/23/2013 Water was flowing from the WS to LS ditch. Not sure where water flow was originating. All erosion problems are still present. (DWR Sutter Yard - afreitag)12/10/2016 Soil erosion around CMP riser and surge concrete box on WS damaged due to overflow. Pump not found. Flap gate missing on WS concrete box. WS slope eroded. Structure might have been used as drainage structure. This needs to be determined during routine inspection. (DWR UCIP - pamatya)

Waterside view: concrete surge box

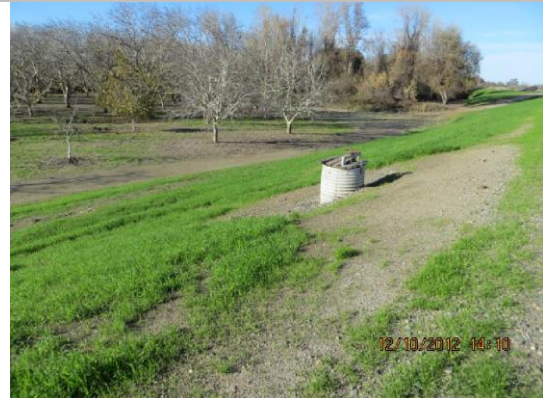
Photo 1 of 3 : UCIP_FA_2018_51750_47349.jpg

FS_ID:51750
DS_ID:17361
EP_NO: N/A
Repair Type: Non-Urgent
Crossing Status: Indicator Found
UCIP Comments: 4/20/2017 Abandoned- needs to be done properly. (DWR Sutter Yard- AFreitag)10/31/2016 Appears abandoned. WS pipe end buried. (DWR Sutter Yard- AFreitag)6/14/2016 WS pipe end was dug up for a internal camera inspection. The WS slide gate was sealed shut and would not open so the inspection was only done form the WS pipe end to the WS slide gate (33.1ft). The pipe showed some signs of heavy rusting but no visible holes or other signs of deterioration were found. After the inspection the WS pipe end was capped and reburied until further abandonment can be achieved.4/2/2015 Only CMP riser on WS. Pipe has been selected for internal camera inspection. Only CMP riser found on WS.7/2/2014 Same as last inspection.12/19/2013 Same as last inspection.7/23/2013 Same as last inspection.
FIELD_STRUCT_DESC: *ABANDONED* 24-inch corrugated metal drainage pipe through the levee, 16 feet below the crown, not found in 2015. Slide gate in a corrugated metal pipe (CMP) riser on the waterside (WS) end, found in 2015. [Additional Reference(s): DWR Levee Log, 2002. USACE Sacramento O&M Manual 136, March 1960 (HLM 13.92)].

Waterside view: CMP riser with slide gate

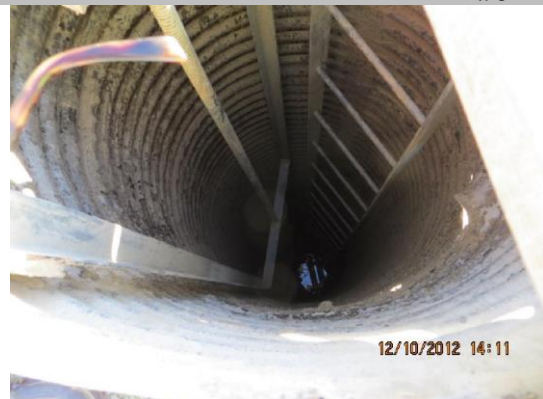
Photo 2 of 3 : UCIP_FA_2018_51750_47348.jpg

Waterside view: inside CMP riser

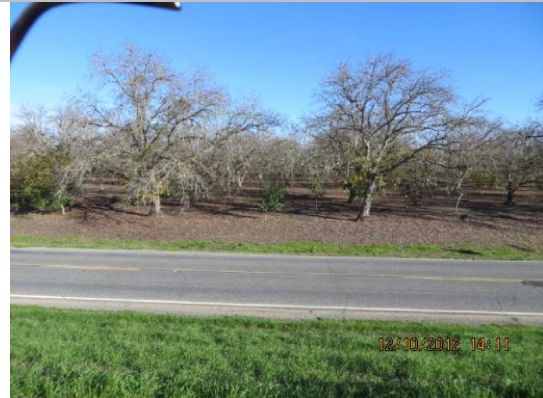
Photo 3 of 3 : UCIP_FA_2018_51750_47347.jpg

Landside view: overview- across the county road

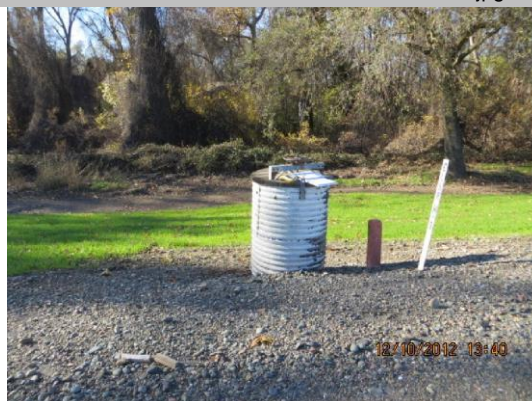
Photo 1 of 3 : UCIP_FA_2018_51752_47356.jpg

Comment Code					
Inspector Comment					
FS_ID:51752 DS_ID:17330 EP_NO: 9508 Repair Type: No Action Needed Crossing Status: Found UCIP Comments: 4/20/2017 Abandoned- needs to be done so properly. (DWR Sutter Yard- AFreitag)10/31/2016 Appears abandoned. WS pipe end buried. (DWR Sutter Yard- AFreitag)6/14/2016 Pipe was internally cleaned and camera inspected on 11/17/2015 by Nor-Cal Pipeline Services. Pipe section through levee is 86ft long and showed some signs of rusting but no visible holes or other deterioration was found. After the inspection the WS end was capped and reburied until further abandonment can be achieved.4/14/2016 Concrete box on LS cleared of sediment.4/2/2015 Same as last inspection. Concrete box on LS silted in. If abandoned it should be done so properly.7/2/2014 Same as last inspection.12/19/2013 Same as last inspection.7/23/2013 Same as last inspection. FIELD_STRUCT_DESC: 24-inch corrugated metal drainage pipe through the levee, 14 feet below the crown. Slide gate in a 36-inch corrugated metal pipe (CMP) riser on the waterside (WS) slope. Concrete distribution box on the landside (LS). (24-inch pipe [HLM 14.5] authorized under Automatic Board Order (ABO) issued as Permit No. 9508, 1974 - Jones). [Additional Reference(s): DWR Levee Log, 2002. USACE Sacramento O&M Manual 136, March 1960 (HLM 14.5)]. FS Date: 5/1/2017 10:34:48 AM

Waterside view: CMP riser with slide gate

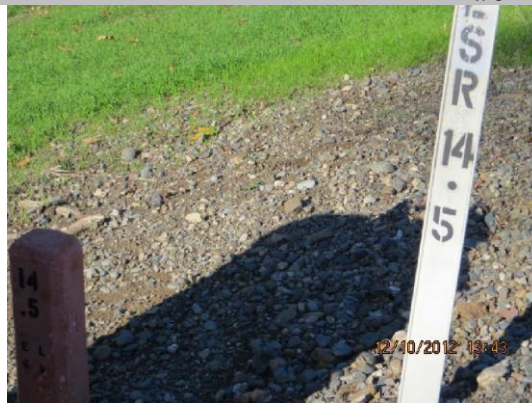
Photo 2 of 3 : UCIP_FA_2018_51752_47361.jpg

Waterside view: levee mile marker

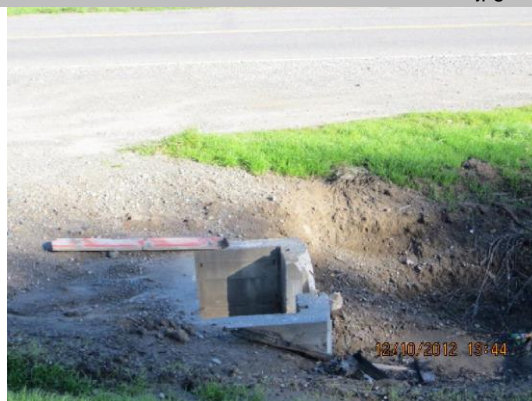
Photo 3 of 3 : UCIP_FA_2018_51752_47360.jpg

Landside view: overview of distribution box
